KSC Ice/Frost/Debris Assessment For Space Shuttle Mission STS-29R

Charles G. Stevenson
NASA/Kennedy Space Center

KSC ICE/FROST/DEBRIS ASSESSMENT
FOR
SPACE SHUTTLE MISSION
STS-29R
MARCH 13, 1989

Approved:
April 30, 1989

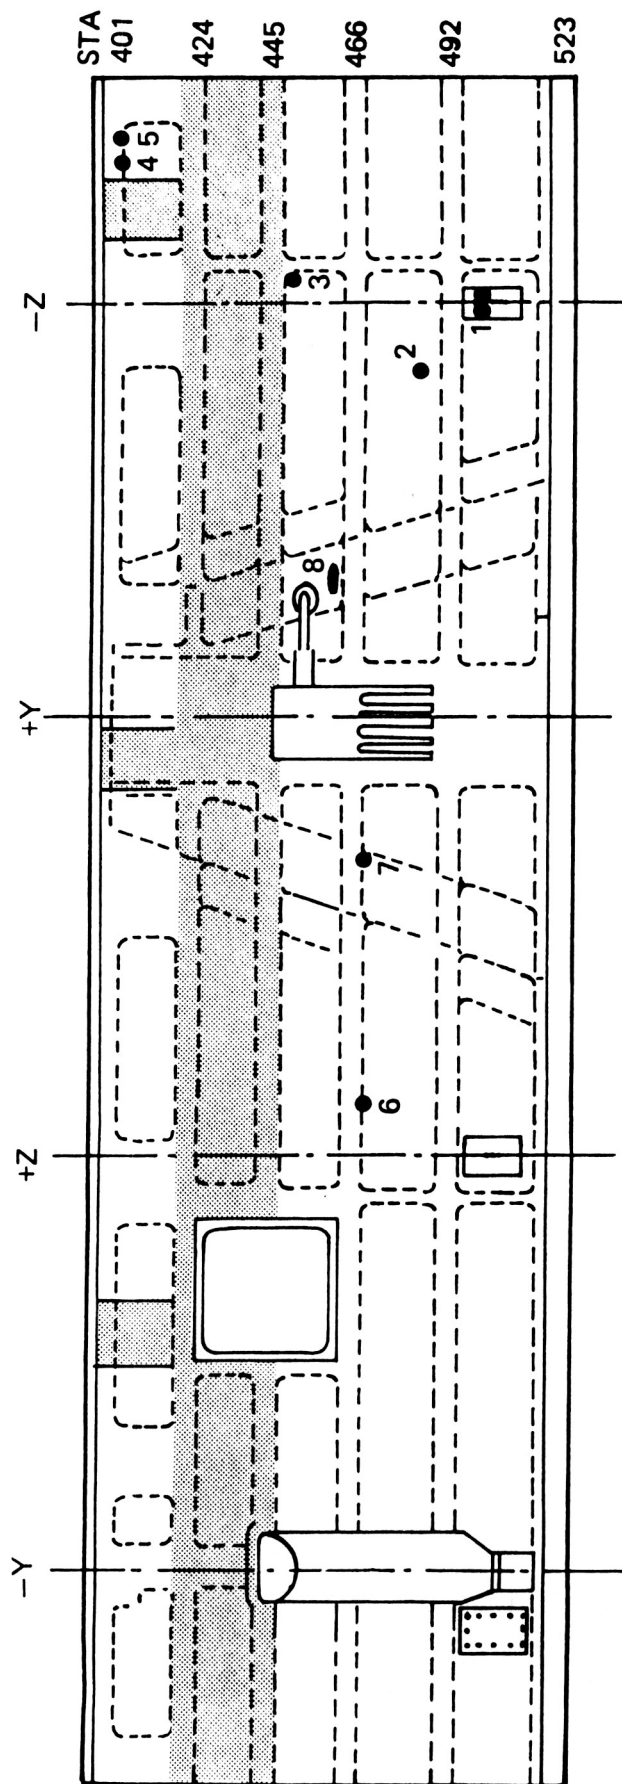
FIGURE 12. LEFT SRB FWD SKIRT

TPS MISSING	DEBONDS
1. 8" x 5" SLA	NONE
2. 1/4" x 1/4" MSA-2	
3. 3/8" x 1/2" MSA-2 TO SUBSTRATE	
4. 1/2" x 1/4" MSA-2	
5. 5/8" x 1/4" MSA-2	
6. 1/2" x 1" MSA-2 TO SUBSTRATE	
7. 1/2" x 1" MTA-2	
8. 2 DIVOTS 1/4" DIA BLISTERS

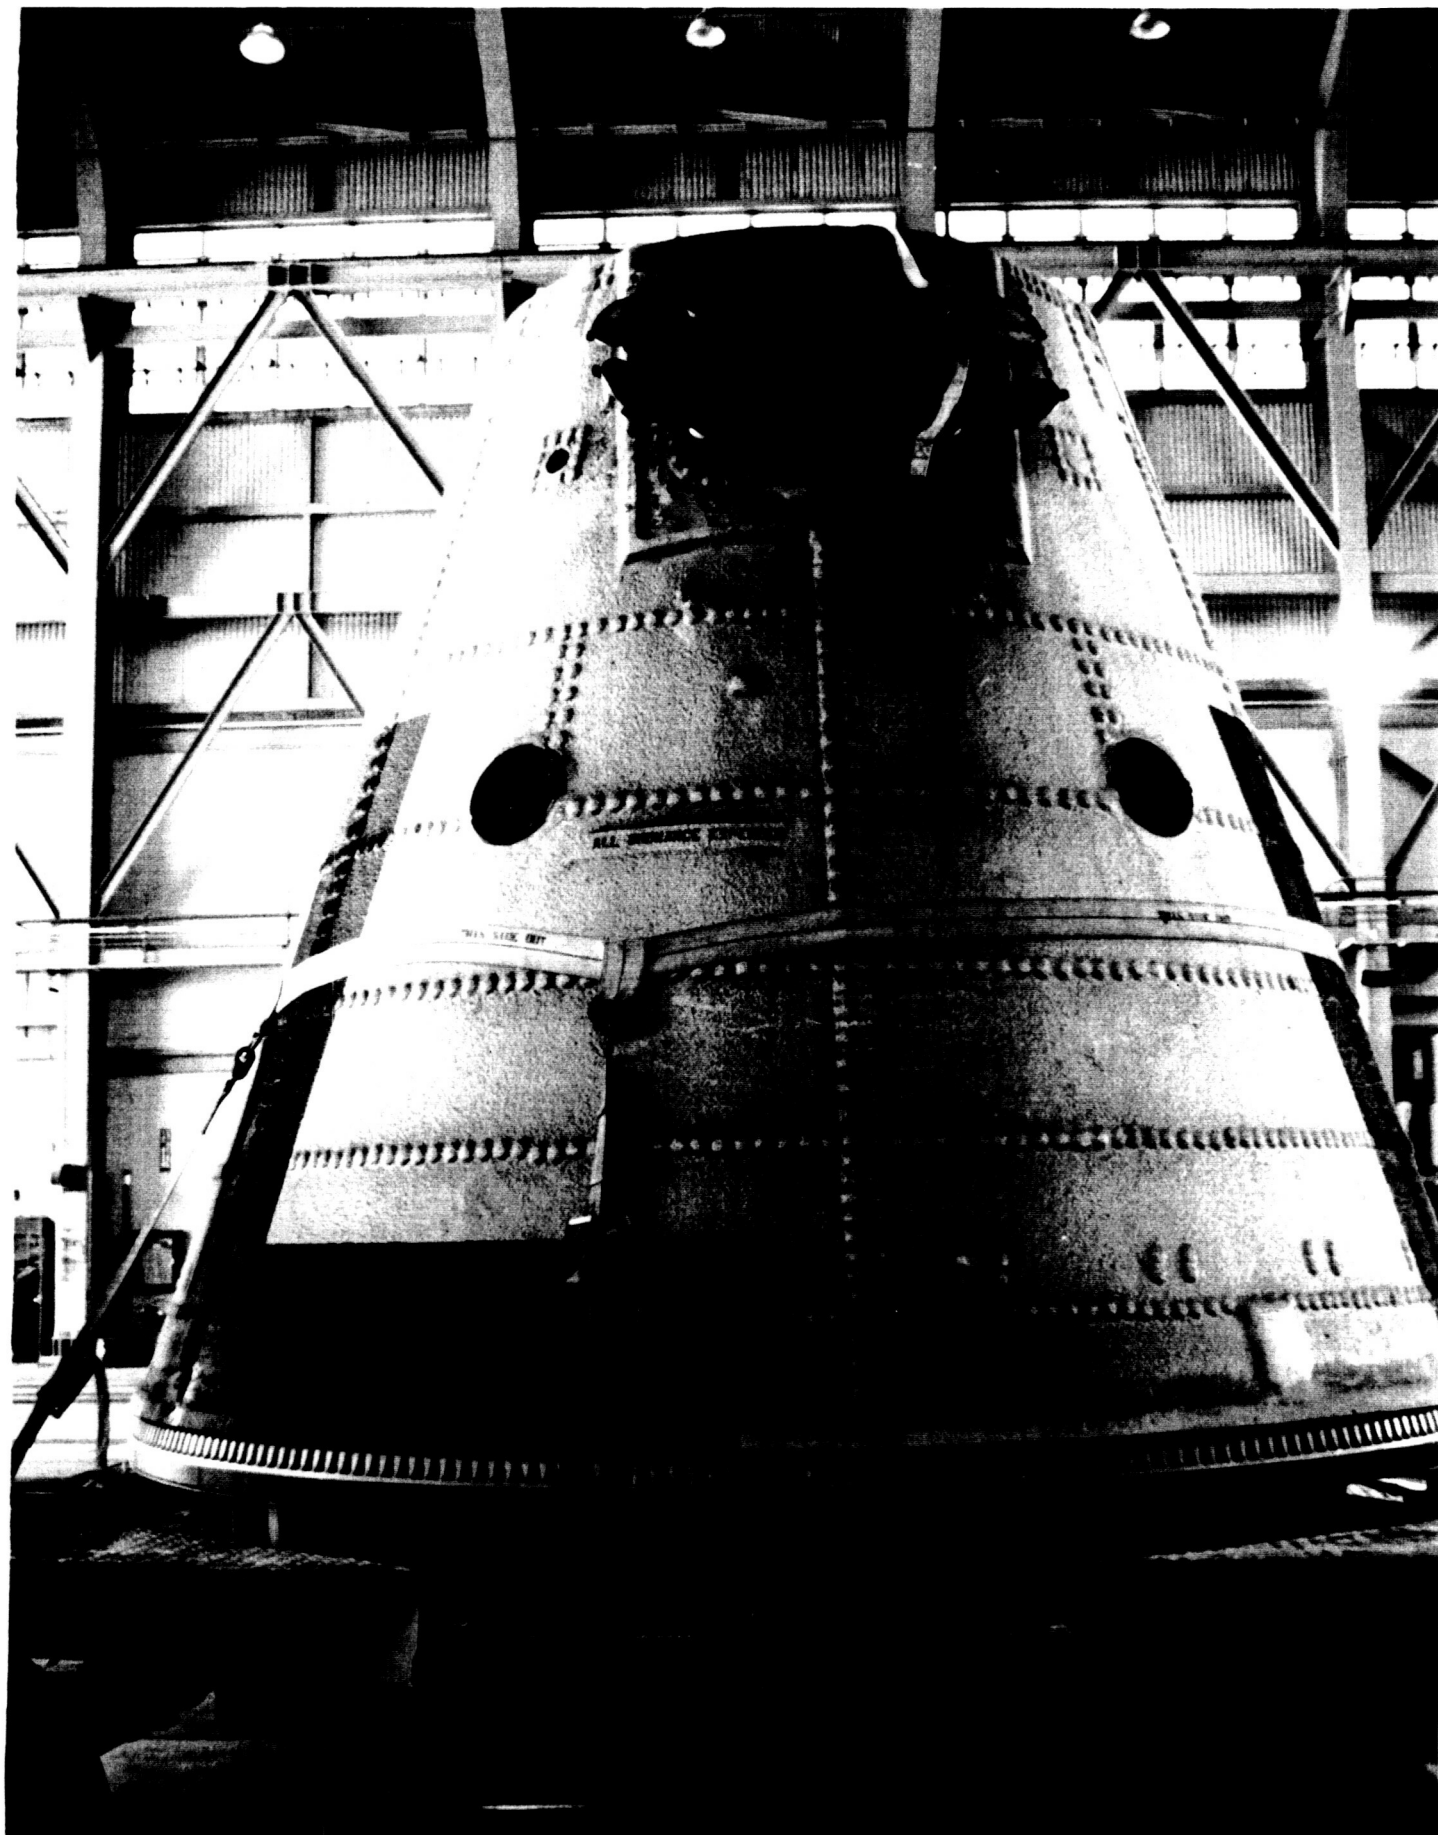
POST FLIGHT CONDITION OF RH SRB FRUSTUM TPS/HYPALON TOPCOAT
ORIGINAL PAGE
COLOR PHOTOGRAPH

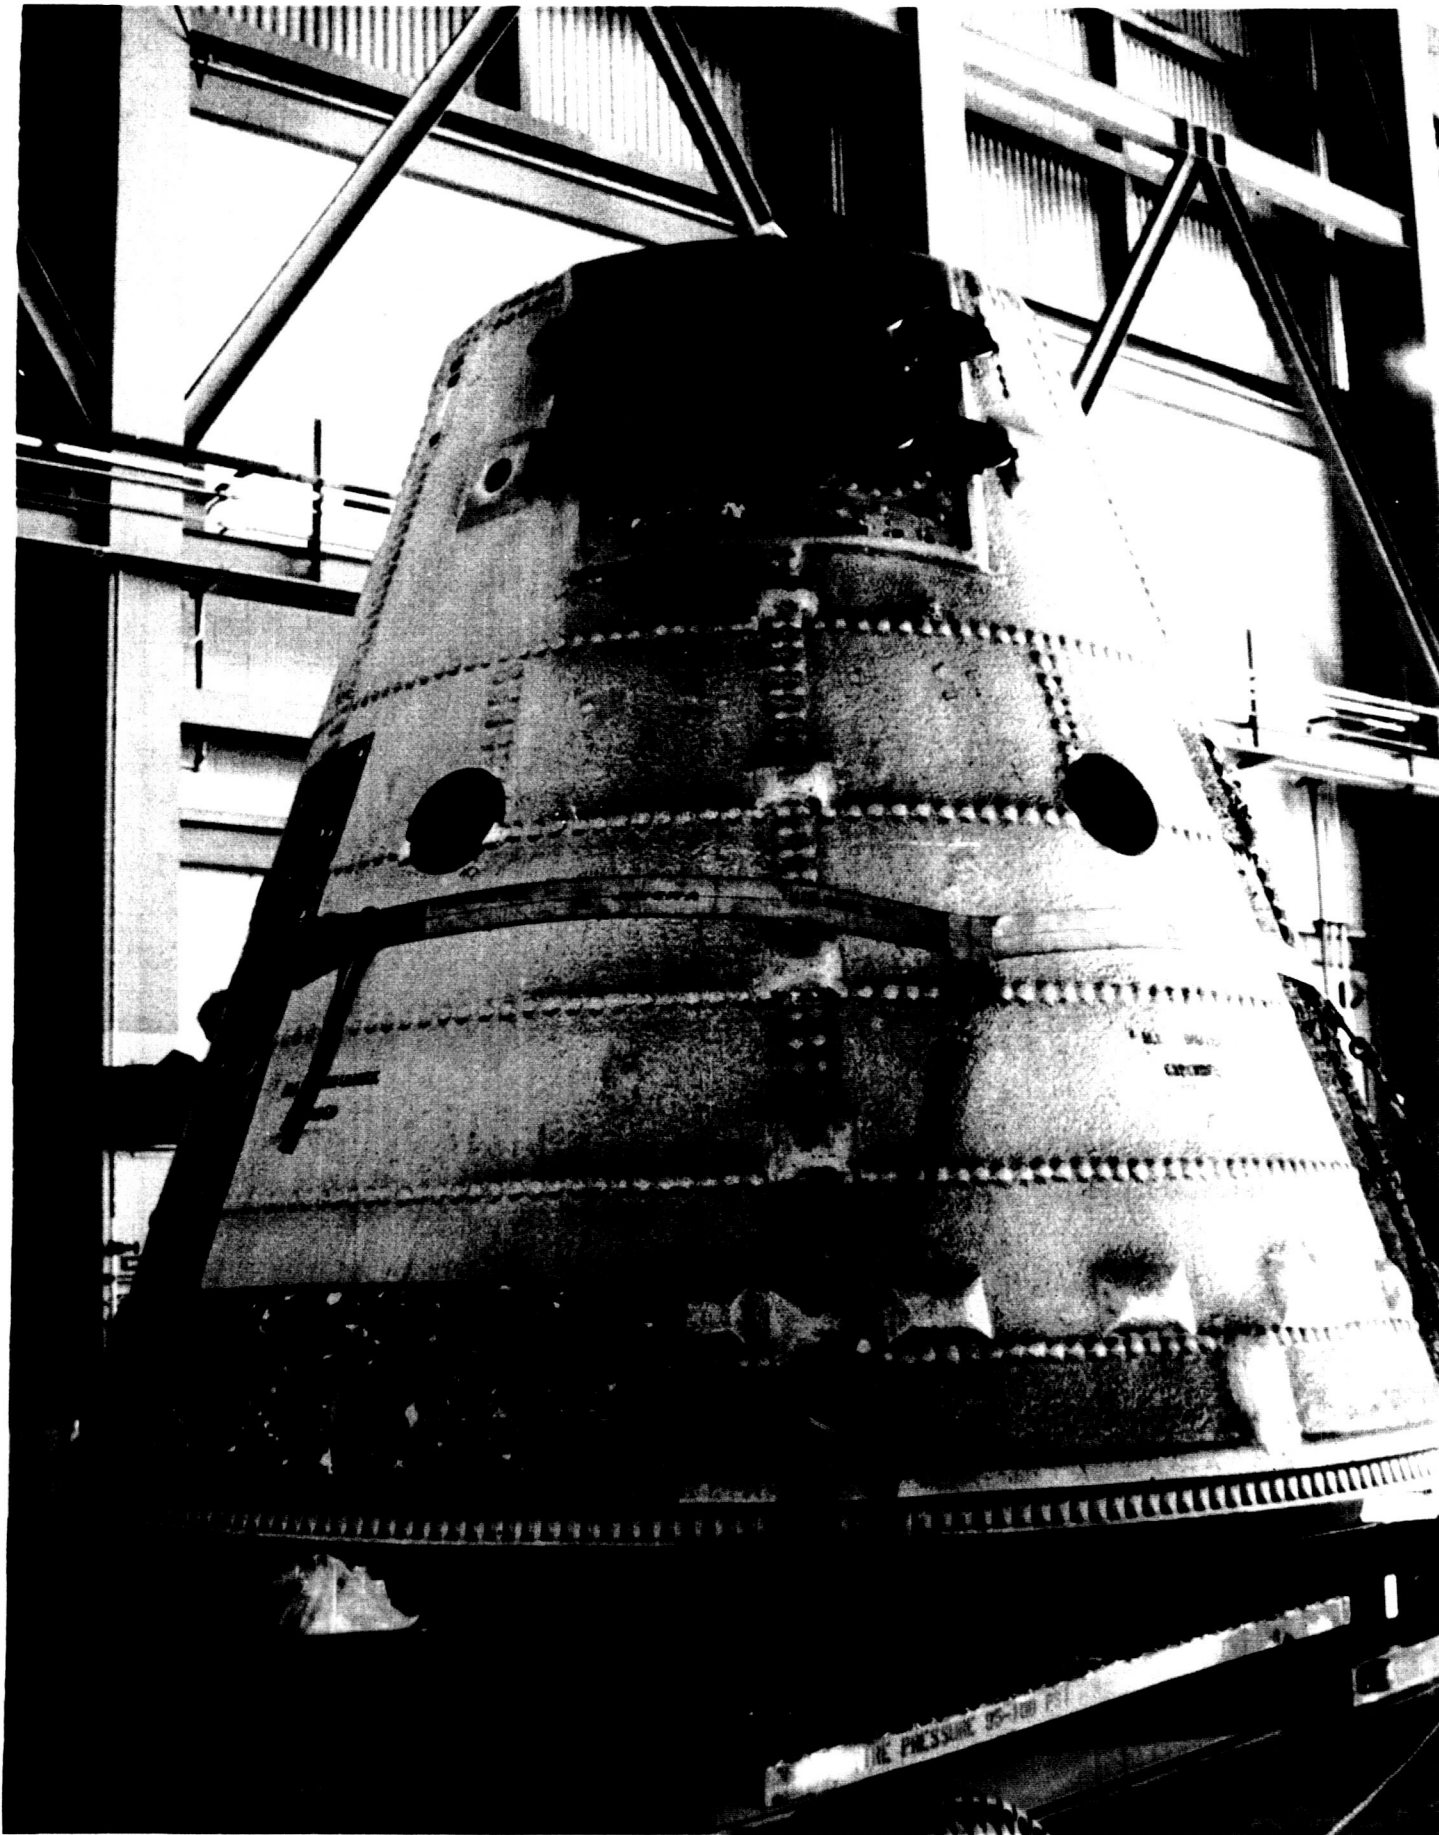
POST FLIGHT CONDITION OF LH SRB FRUSTUM TPS/HYPALON PAINT
SEVERE BLISTERING OCCURRED IN BLACK VISIBILITY STRIPE

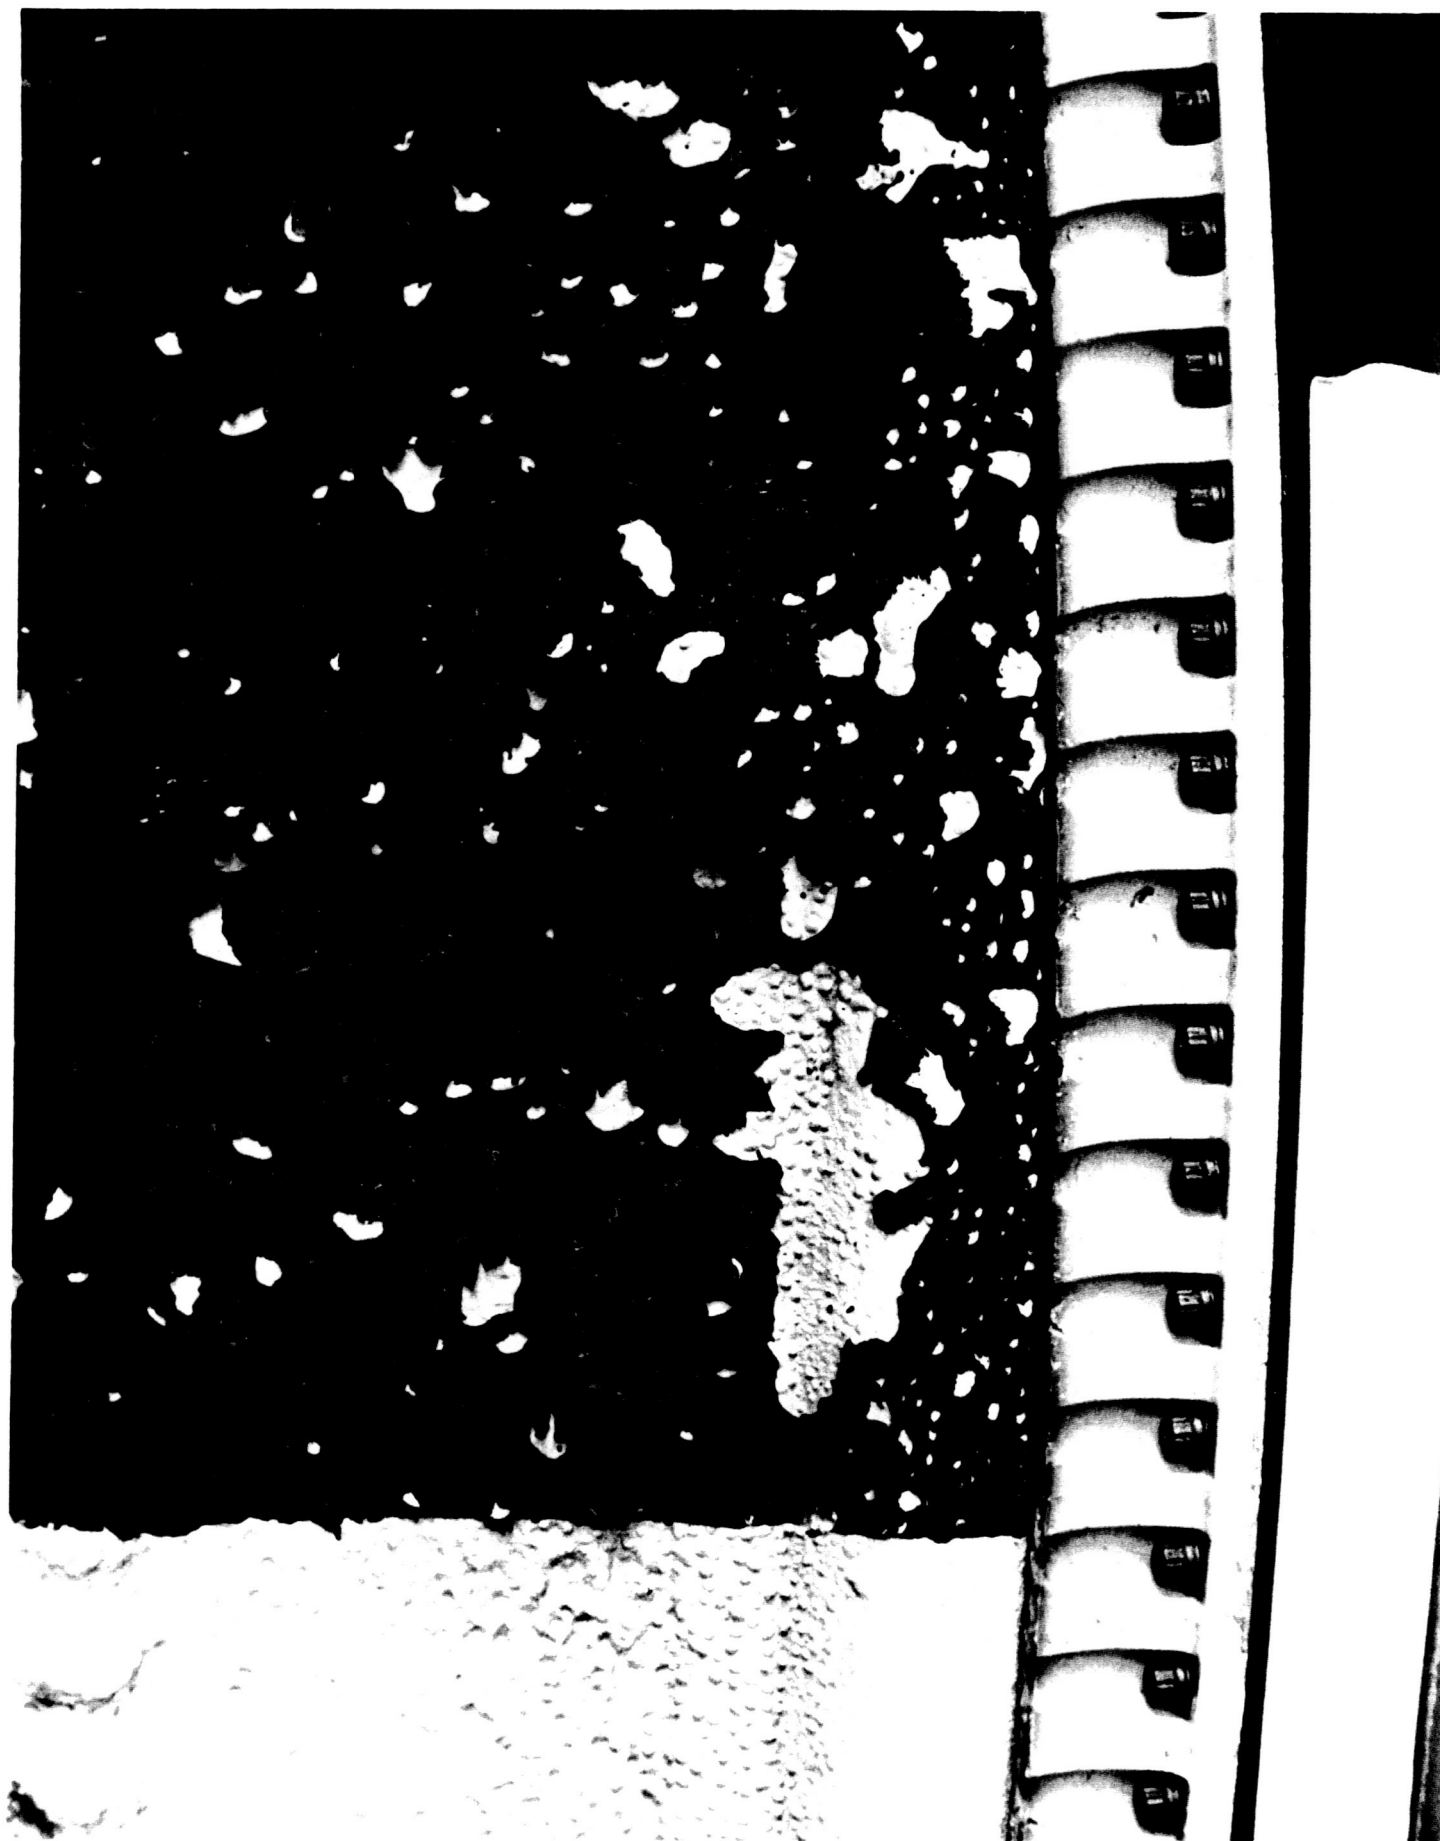
BLISTERS IN THE BLACK HYPALON TOPCOAT RANGED IN SIZE FROM
1/8-INCH TO 5 INCHES IN DIAMETER

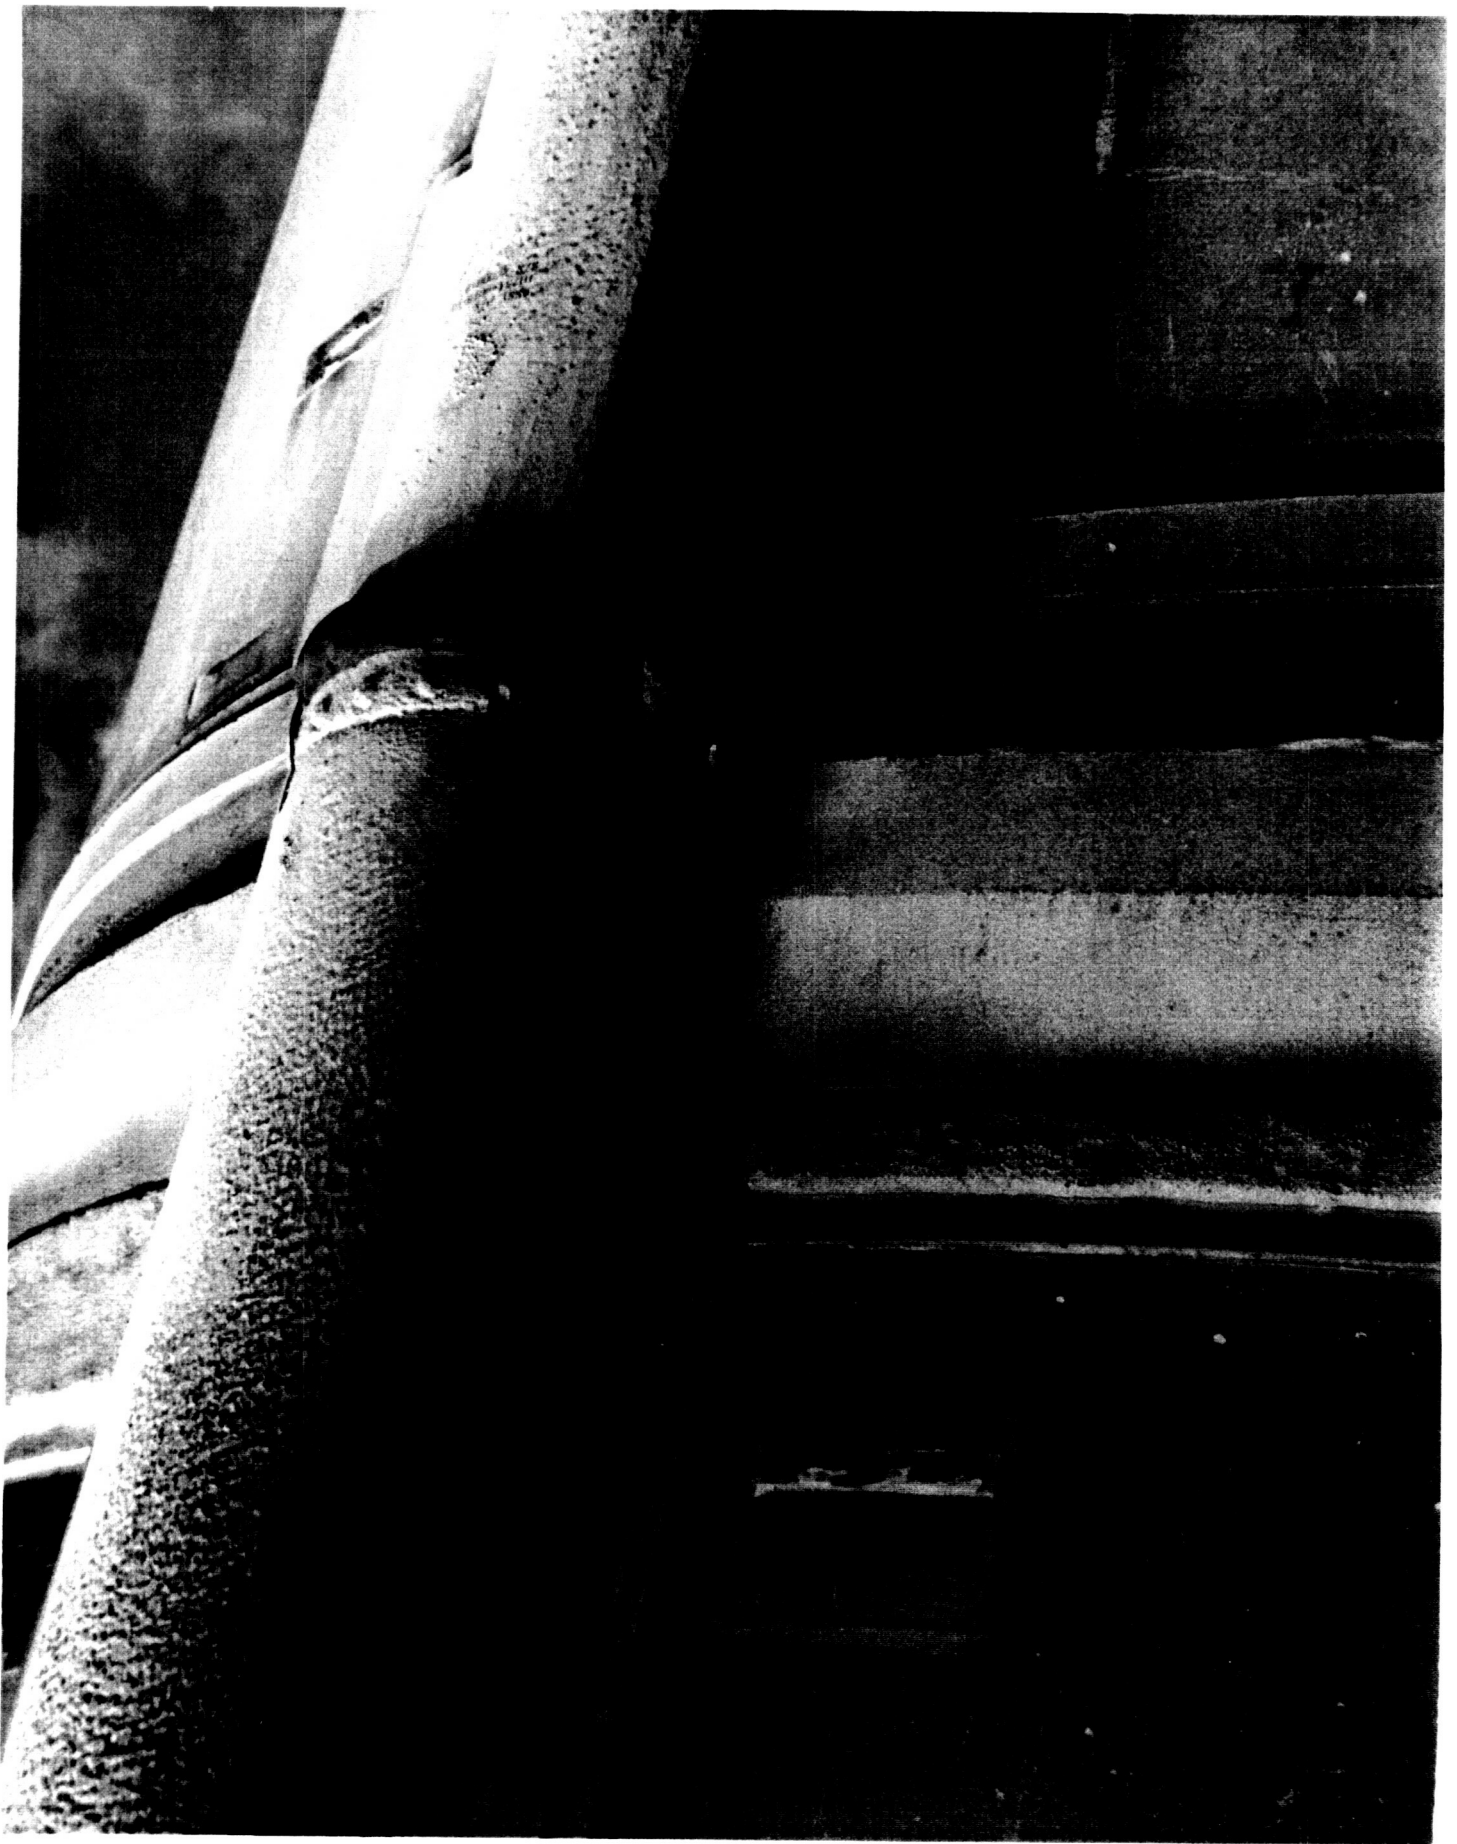
LARGE K5NA CABLE CLOSEOUT ON RH FWD SEGMENT EXCEEDS ALLOWABLE
PROTUBERANCE LIMIT. NOTE MISSING GEI MSID TAG.

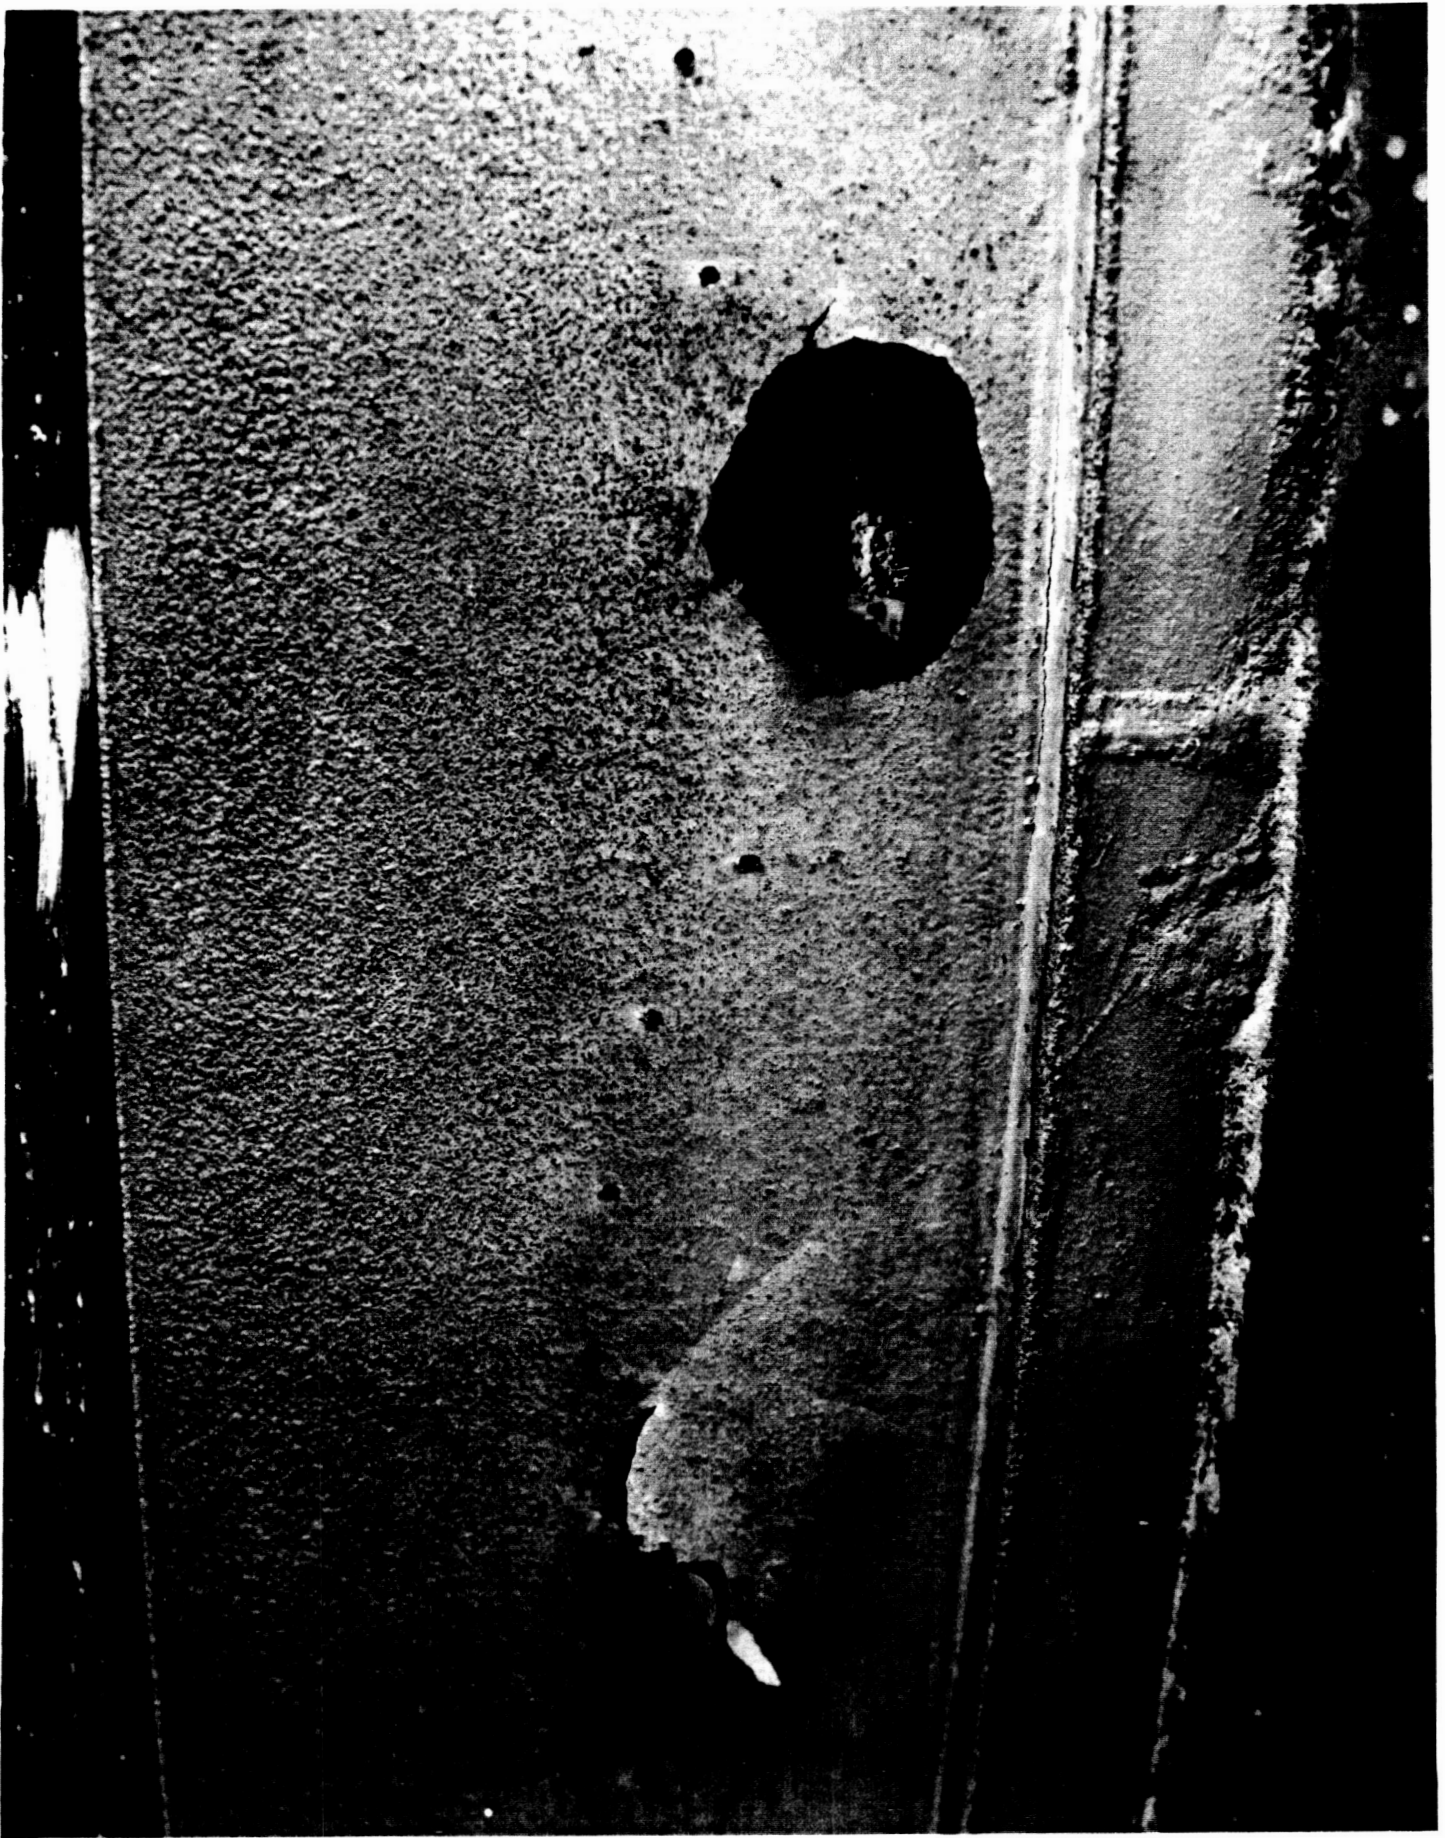
LOSS OF JOINT PROTECTION SYSTEM CORK MATERIAL
IN SPITE OF DRILLED VENT HOLES

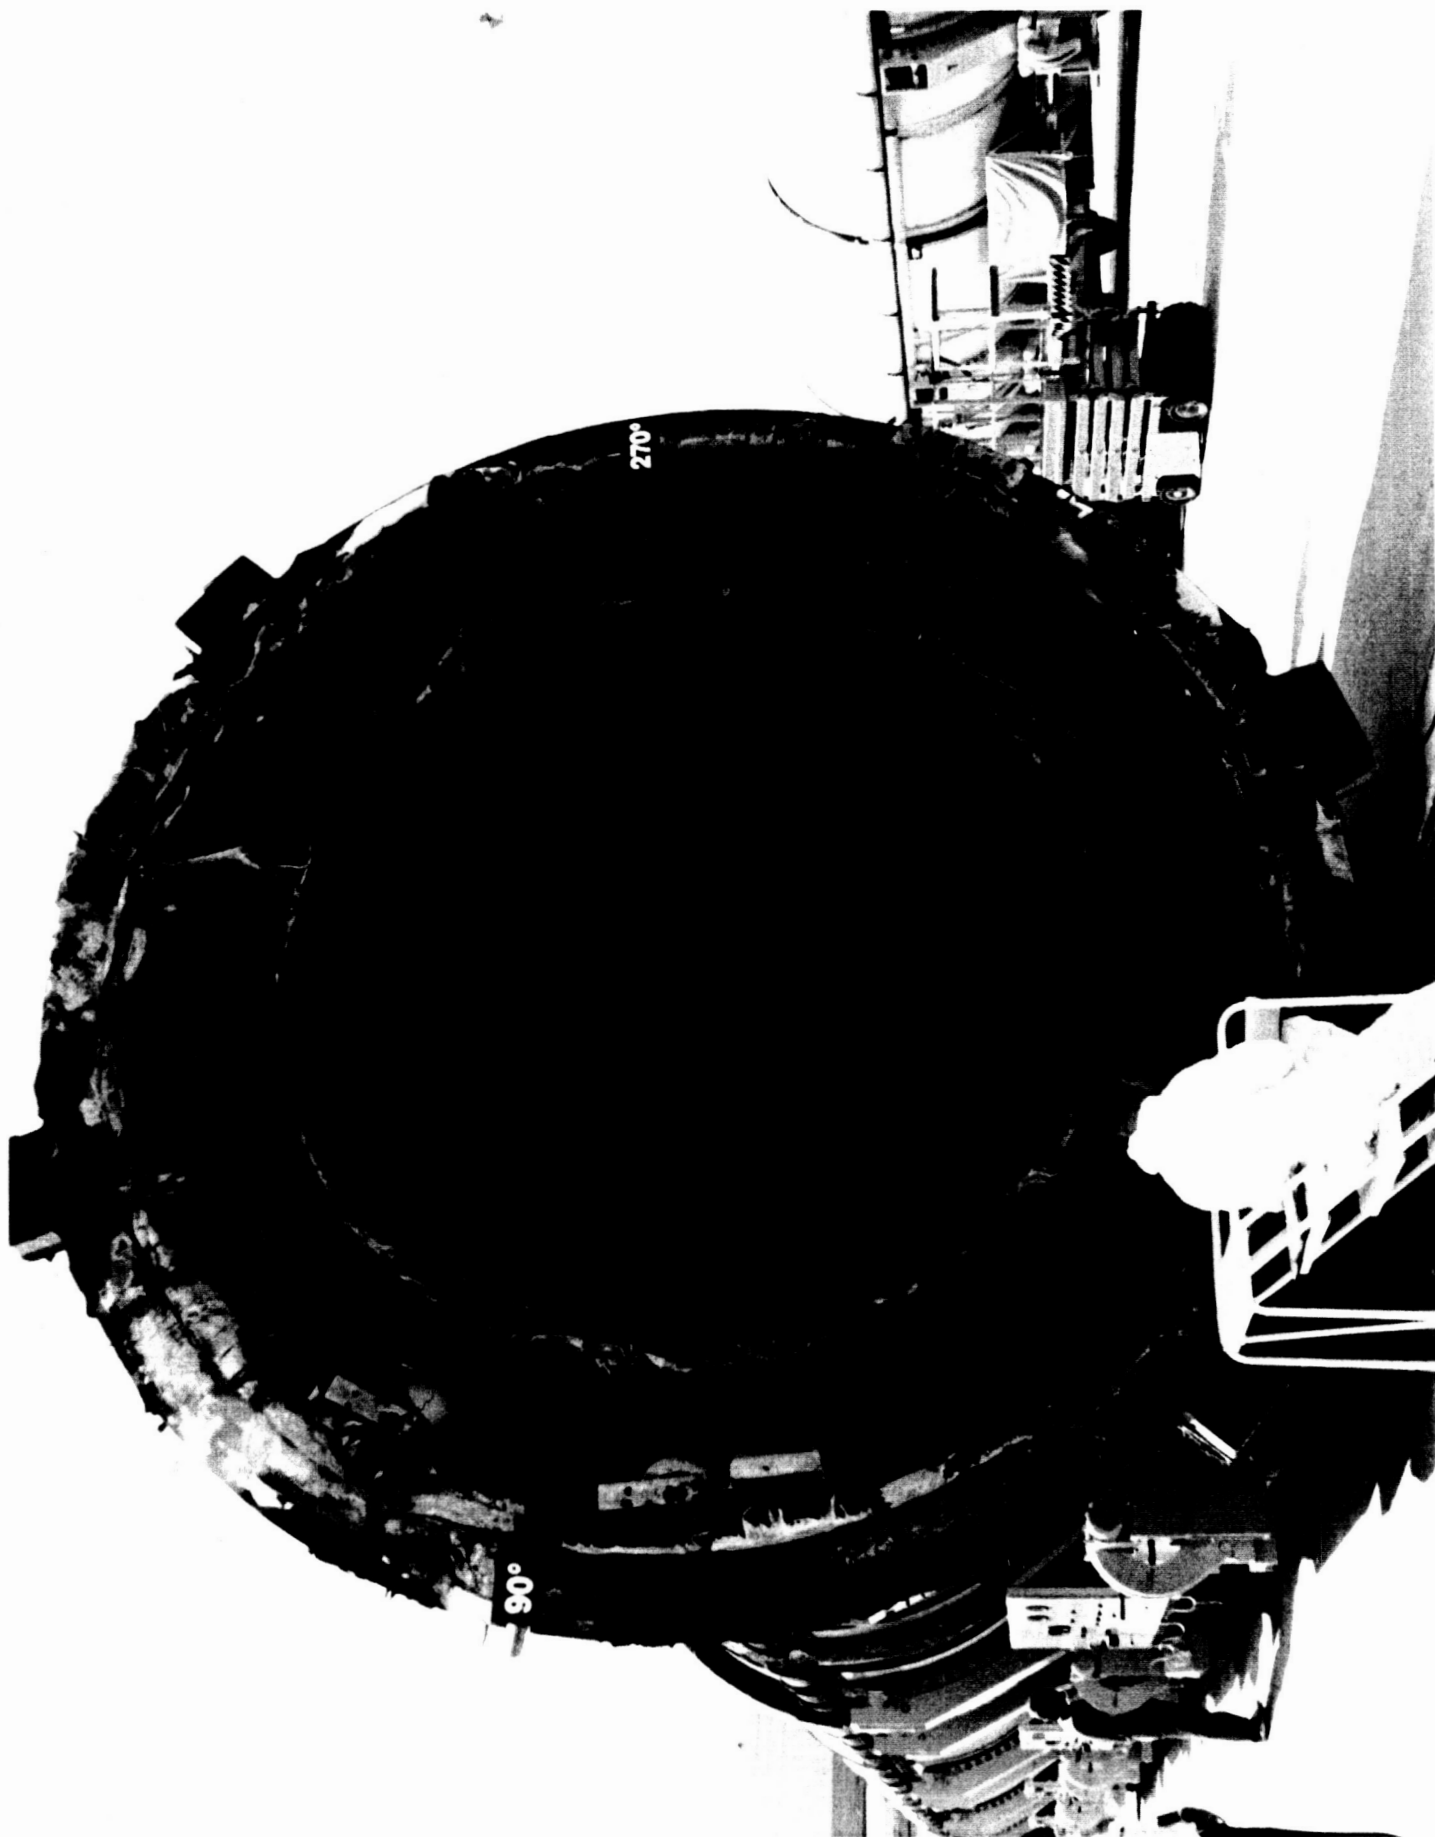
MISSING/CHARRED AFT SKIRT INSTAFOAM

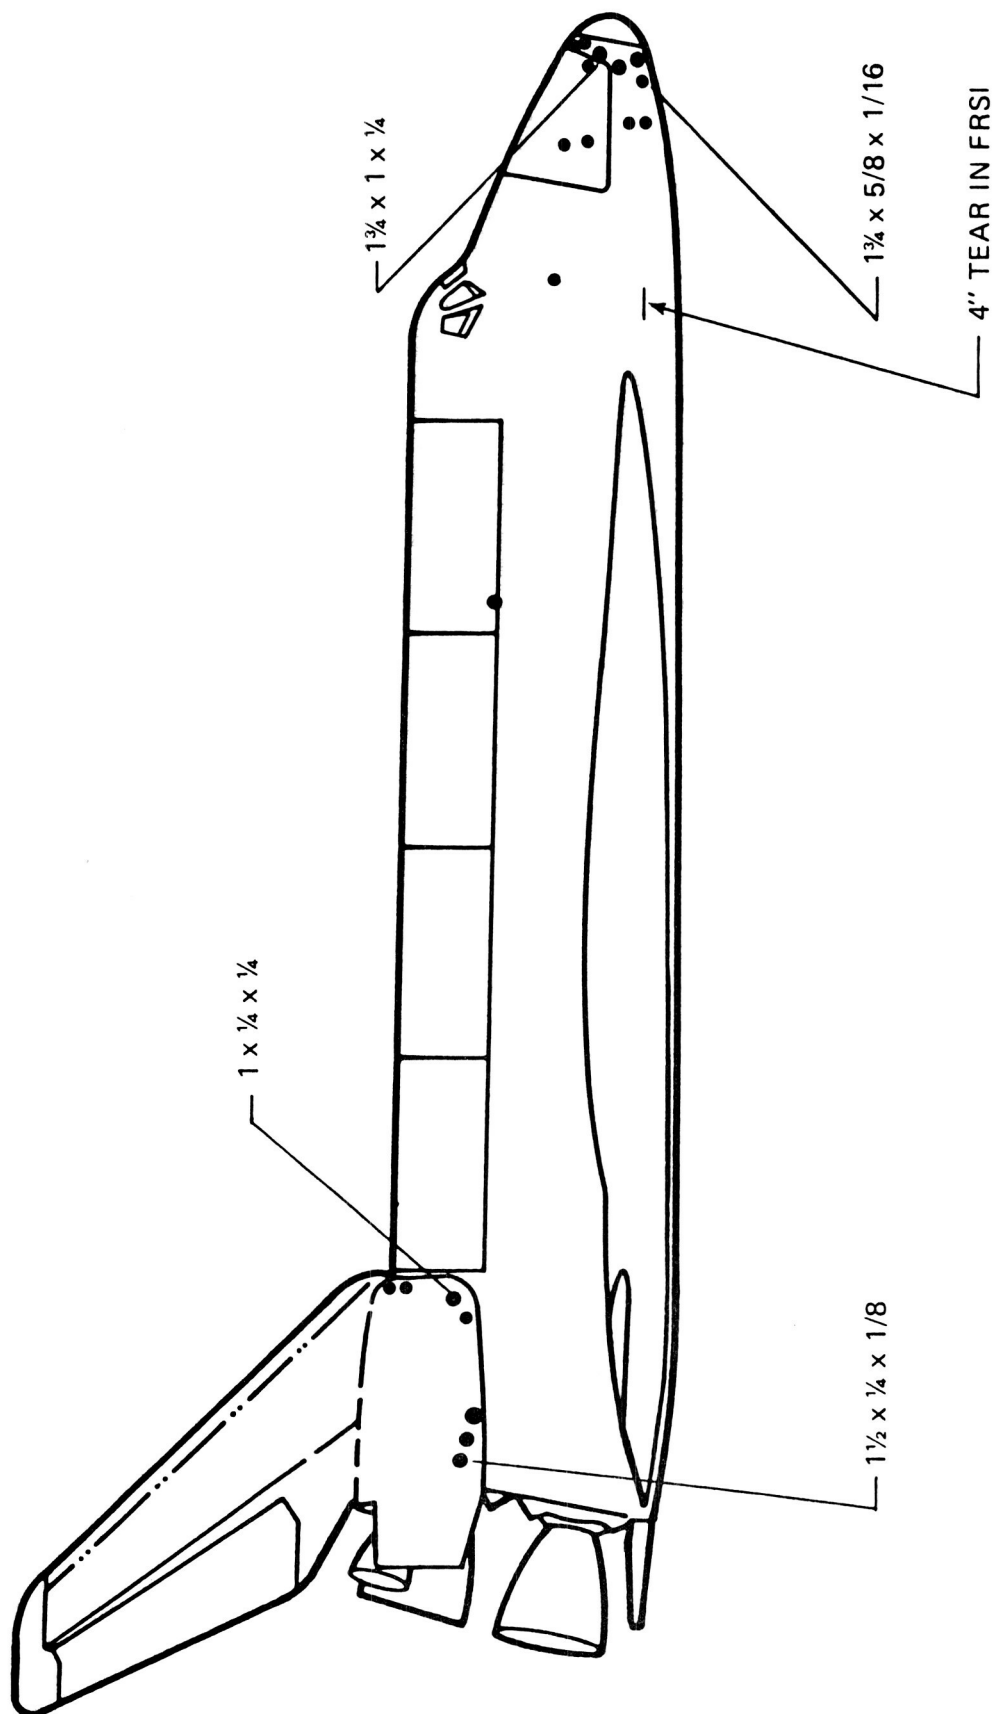
FIGURE 17
DEBRIS DAMAGE LOCATIONS

TOTAL HITS = 21
HITS \geq 1 INCH = 4

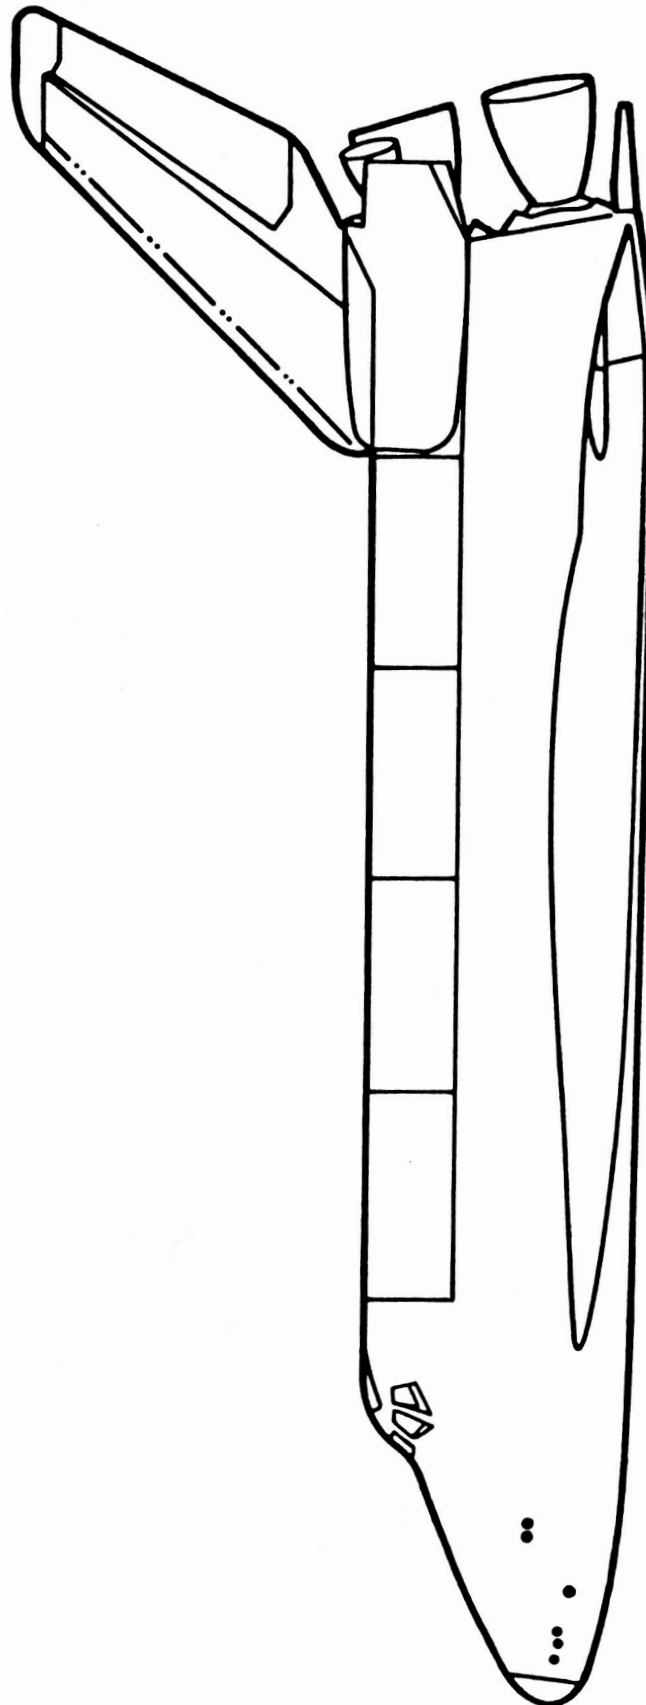
FIGURE 18
DEBRIS DAMAGE LOCATIONS

TOTAL HITS = 6
HITS \geq 1 INCH = 0

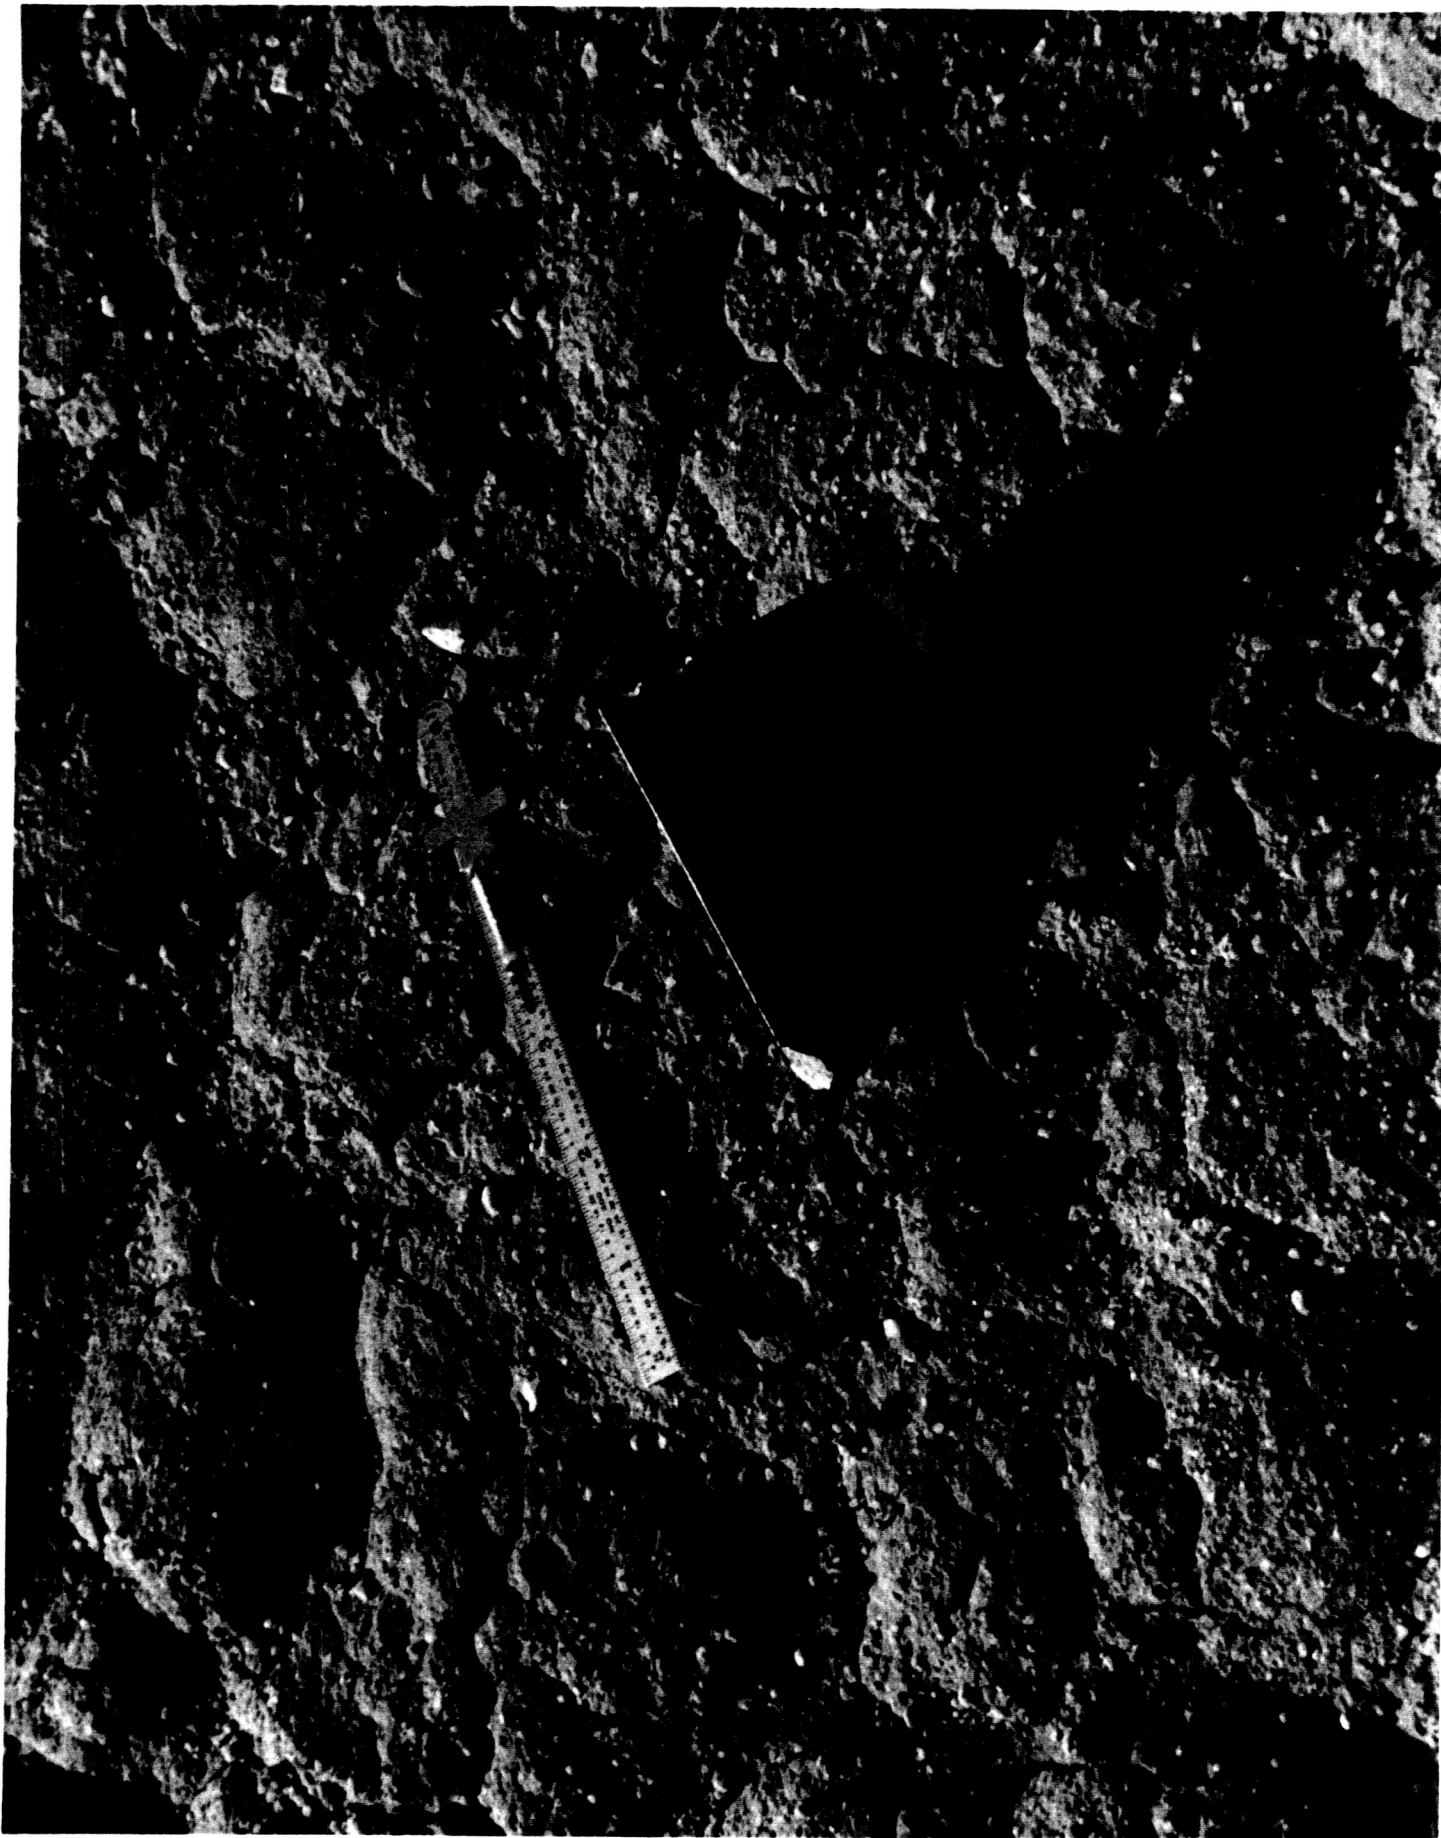
PIECE OF TILE FROM RH MLG DOOR FOUND NEAR RUNWAY THRESHHOLD
